River Restoration for Wildlife

—In and Out of the Water

A River Restoration Plan (cont.)

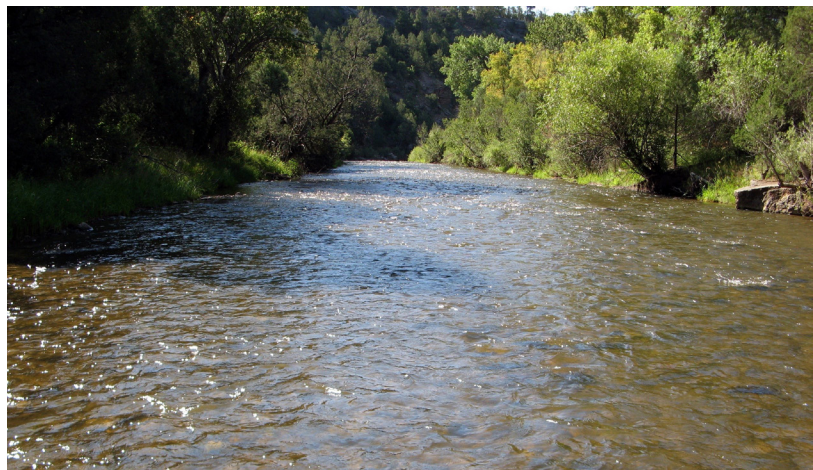
July 2007. A 225-yard stretch of the Pecos River. Straight, no meanders, poor sport fish habitat.

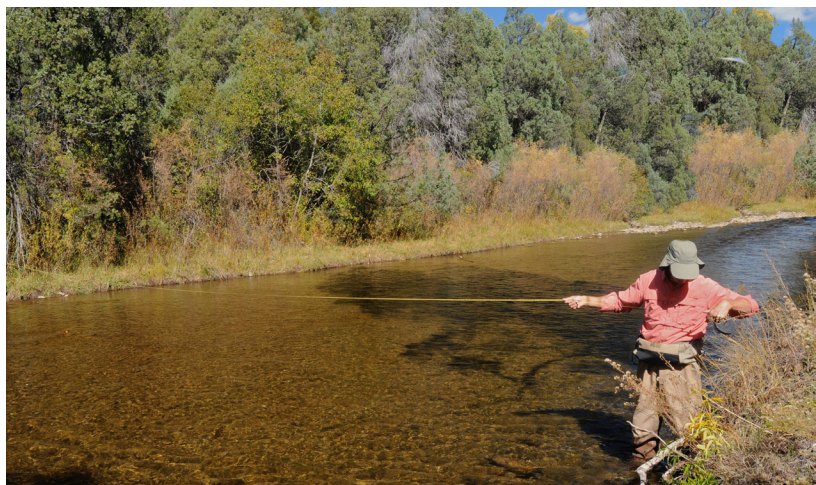
September 2007. Measuring stream width.

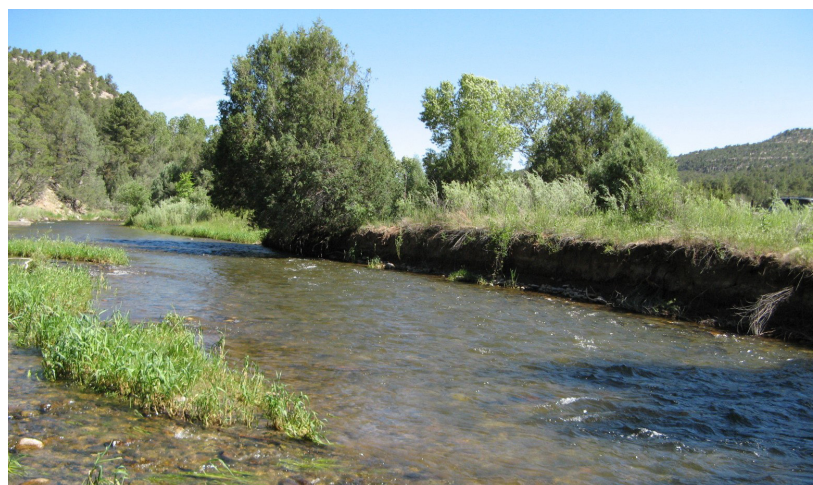
July 2007 Steep, cut banks. High turbidity during spring runoff and flood events.

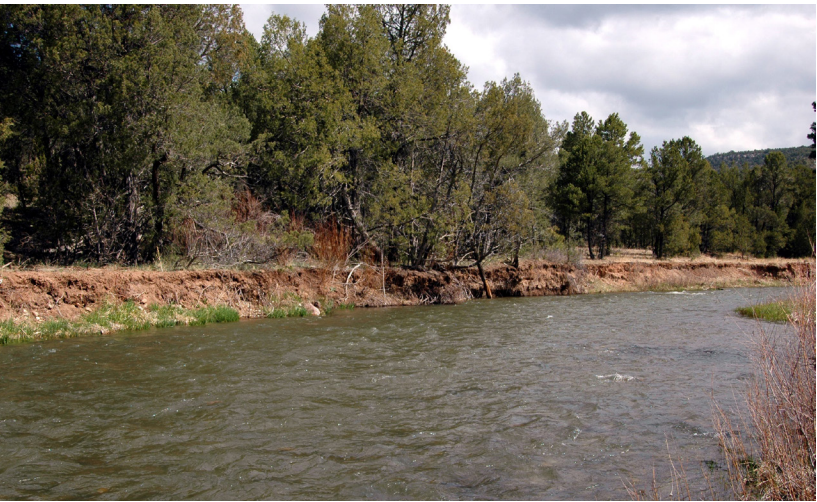
BEFORE: post-spring runoff, June 2007.

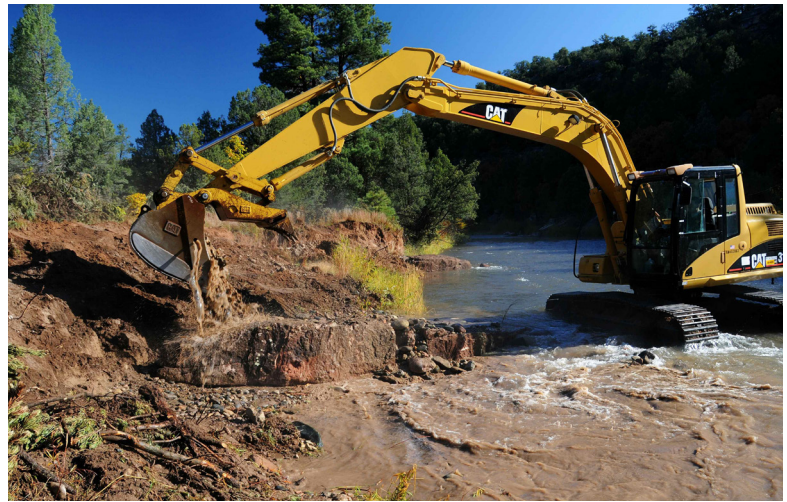
October 2008. Installing "boulder barbs" designed to protect the bank and move the force of the river 8 to 10 feet offshore.

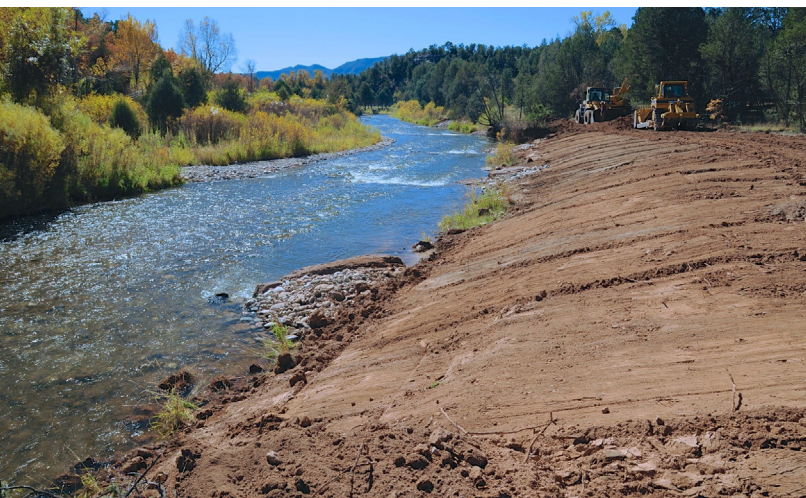
October 2008. Shaving the bank to encourage the establishment of riparian vegetation.

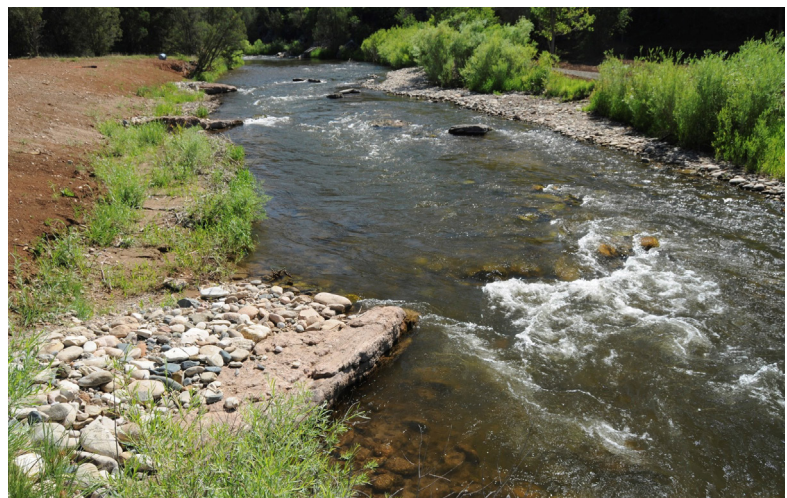
June 2009. The boulder barbs are beginning to "lock in" as organics are filling in. Grasses are starting to establish. Large cobble gravel bars emerge as water level drops.

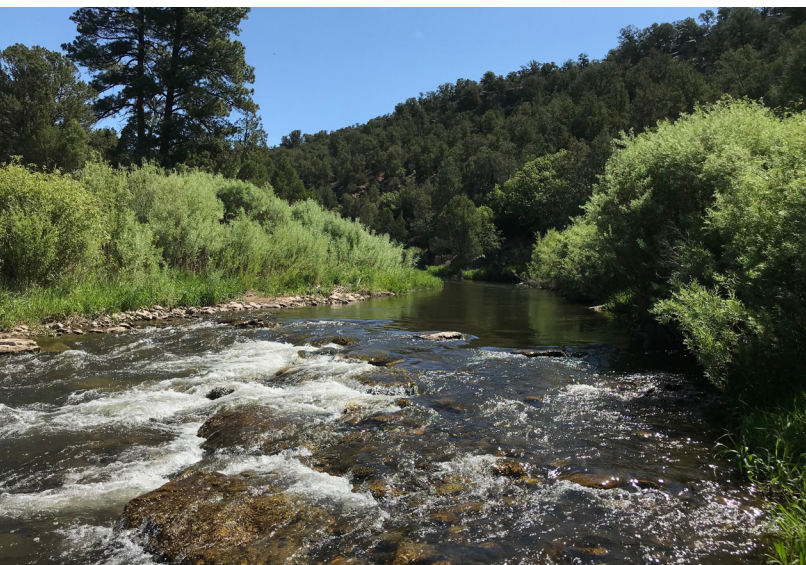
Riffle drop structures are used to deepen the upstream pool/run habitat, regulate stream velocity and provide habitat for macro-invertebrates.

1) establishing shallow riffle drop structure (see photo, left page, bottom left) for macro-invertebrates and controlled velocity; 2) interconnecting runs to allow sport fish and forage fish to travel freely; 3) establishing deep pool habitat (refugia for low summer flows and winter ice-over); 4) maintaining in-stream islands to provide narrow side channels for spawning habitat

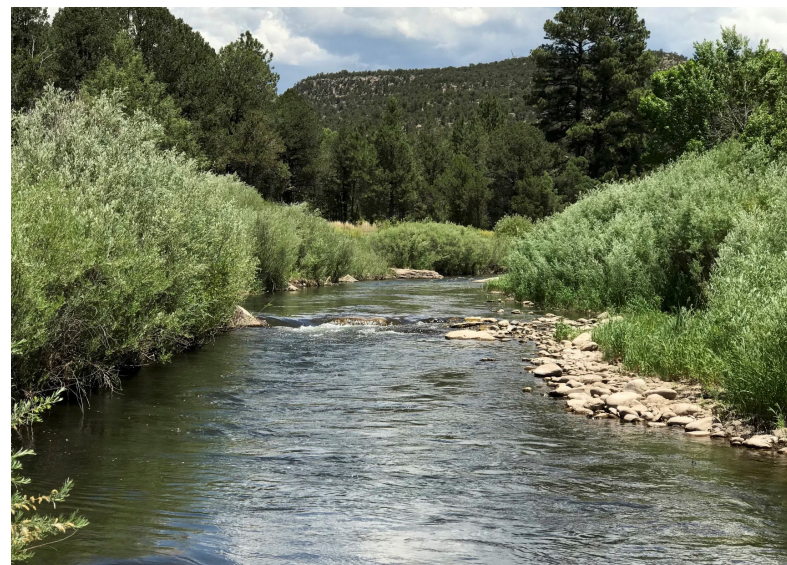
July 2020. The Pecos River as it looks today.
